Avondale Facility Statistics	
Nearest Town:	Avondale
County:	Pueblo
River Basin:	Middle Arkansas
Receiving Water Body:	Green Arroyo
Year Online:	1996
Population:	1,000
Elevation (feet):	4560
Design Flow (mgd):	0.110
Average Flow (mgd):	0.080
Size (acres):	0.87

Facility Description

Wetland Design

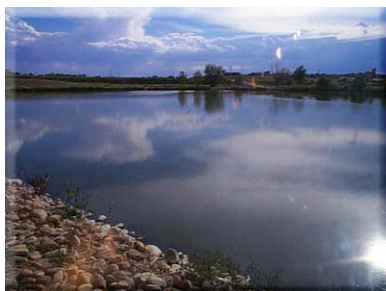
10-acre facultative lagoon system, prior to wetland cells

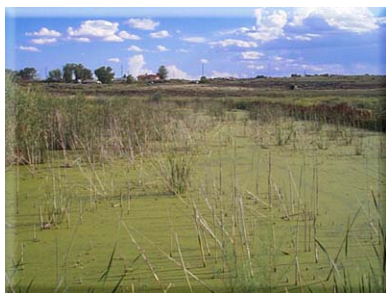
Portion of wetland cell with some plant die-off

The wastewater wetland is part of a restricted public access area, and has never been used for educational purposes. At the time of the site visit, the aesthetic value of this wetland was low because of recent vegetation die offs. However it has potential to have moderate aesthetic value with viable vegetation.

Wetlands would benefit from either lowering the water level or raising the soil surface. The overall system performance could be improved by incorporating a mechanism to allow the water level in the wetland to be lowered.

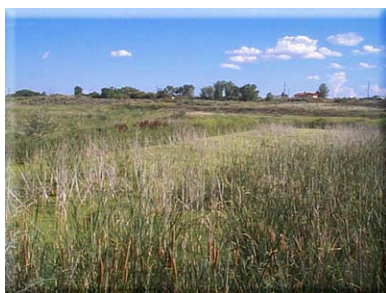
Wetland cell

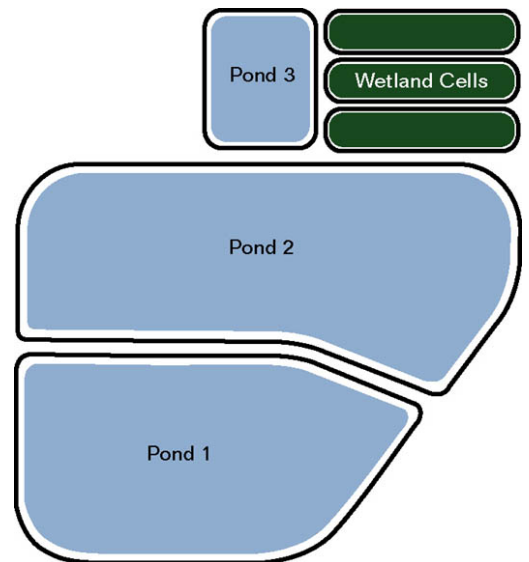
The individual area for the three wetland cells is approximately 12,750 ft² for a total area of 38,250 ft².

As the schematic to the right shows, Avondale constructed wetland cells are flat and rectangular, with an area of approximately 0.3 acres each.

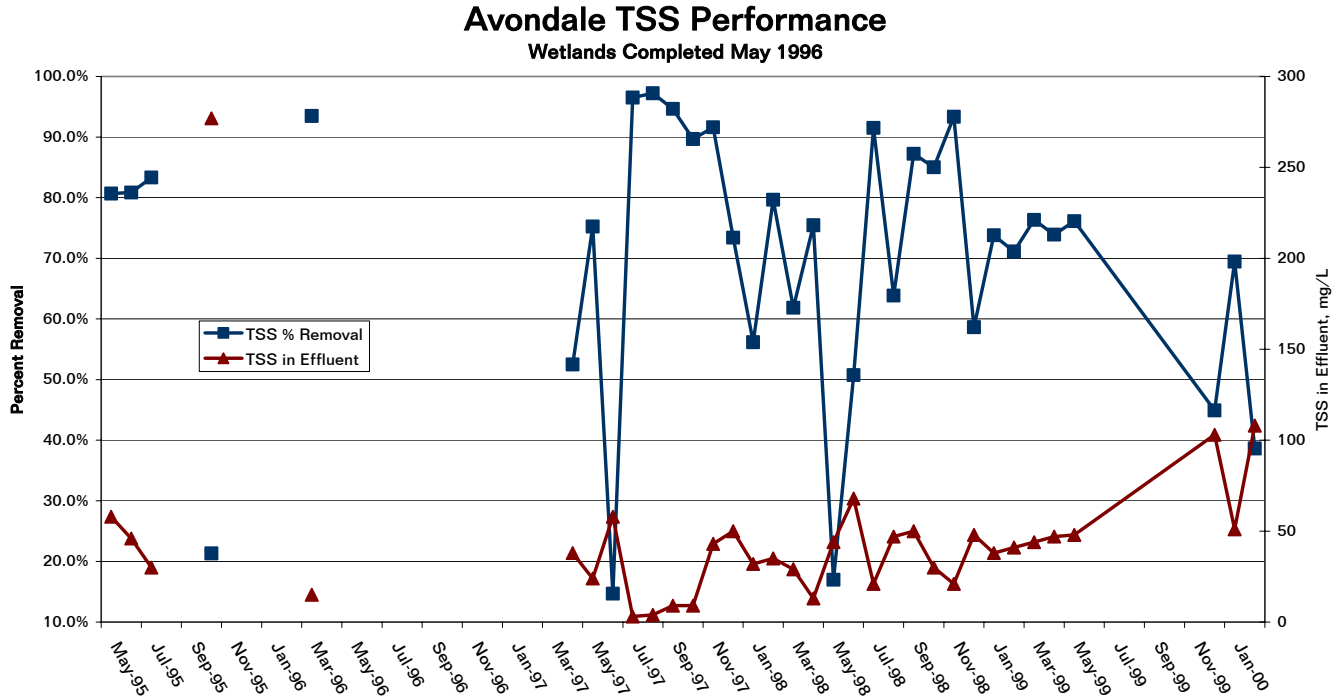
TSS Data

Some general observations can be made by reviewing the plotted 30-day average TSS data. The TSS graph plots the percent removal on the left axis and TSS in mg/l in the effluent on the right axis. In the months before the wetland was implemented, there was no discharge from the treatment facility. Since no discharge

was occurring, data for this period were not reported. Trends in the TSS data indicate that TSS in the effluent has consistently been below permit limitations. The most current data indicate that TSS in the effluent has been increasing, while percent removal in the system has been decreasing.

The discharge permit limitation for TSS in the effluent is 105 mg/l for the 30-day average. Monthly reports submitted to the CDPHE record an average daily TSS in the influent, since the wetlands have been operating, of 165 mg/l. The average TSS in the effluent is recorded to be 40 mg/l. This removal clearly meets the discharge requirements of 105 mg/l.

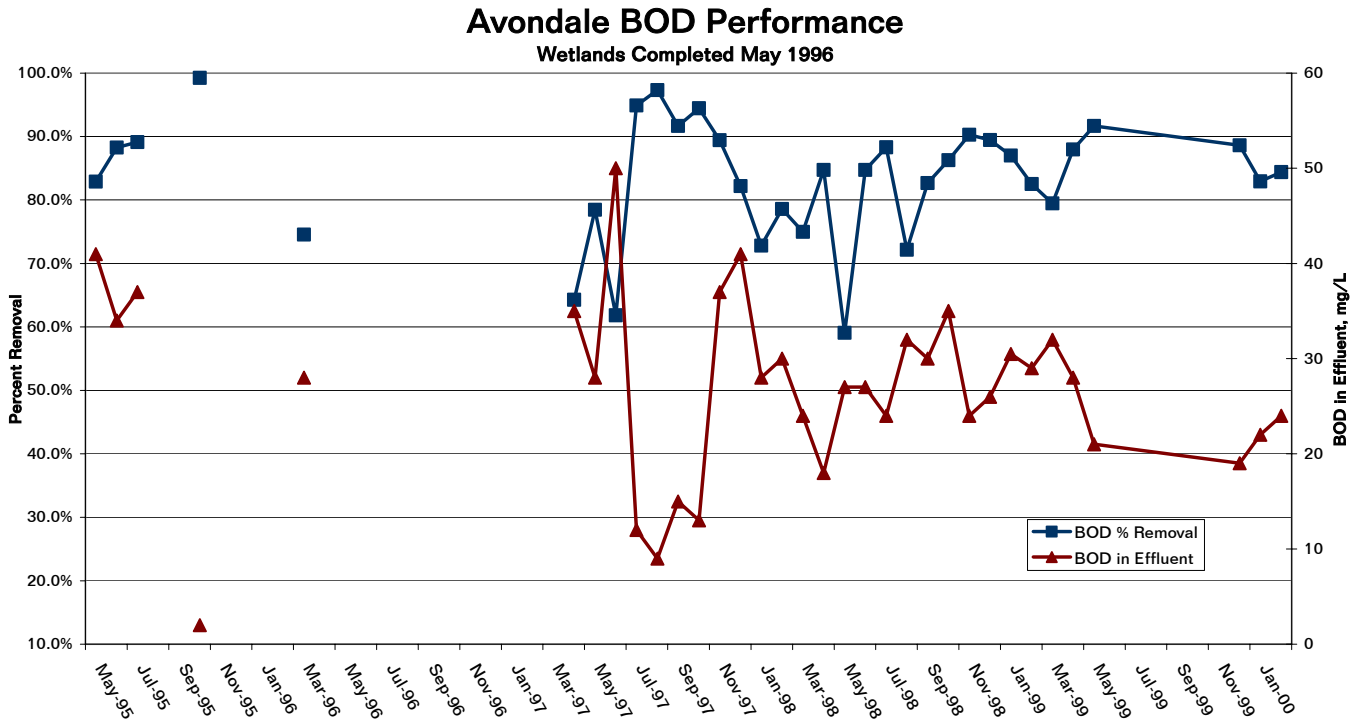
BOD Data

The BOD data is plotted similarly to the TSS data, with mg/l in the effluent on the right axis, and percent removal on the left axis. The data previous to the wetland implementation is scant, as discharge was not occurring during this period. The permit for this system changed from reporting BOD₅ to reporting CBOD₅. Tests indicate that there is little difference between the two at this system. The data from this system indicates that CBOD values have exceeded permit limitations. The average CBOD in the influent, since wetland implementation, has been 185 mg/l, with an average effluent amount of 27 mg/l. This average value is slightly higher than the permitted value of 25 mg/l. The percent removal in the system recorded an average value, during this same period, of 83 percent. This removal is slightly lower than the permitted removal of 85 percent.

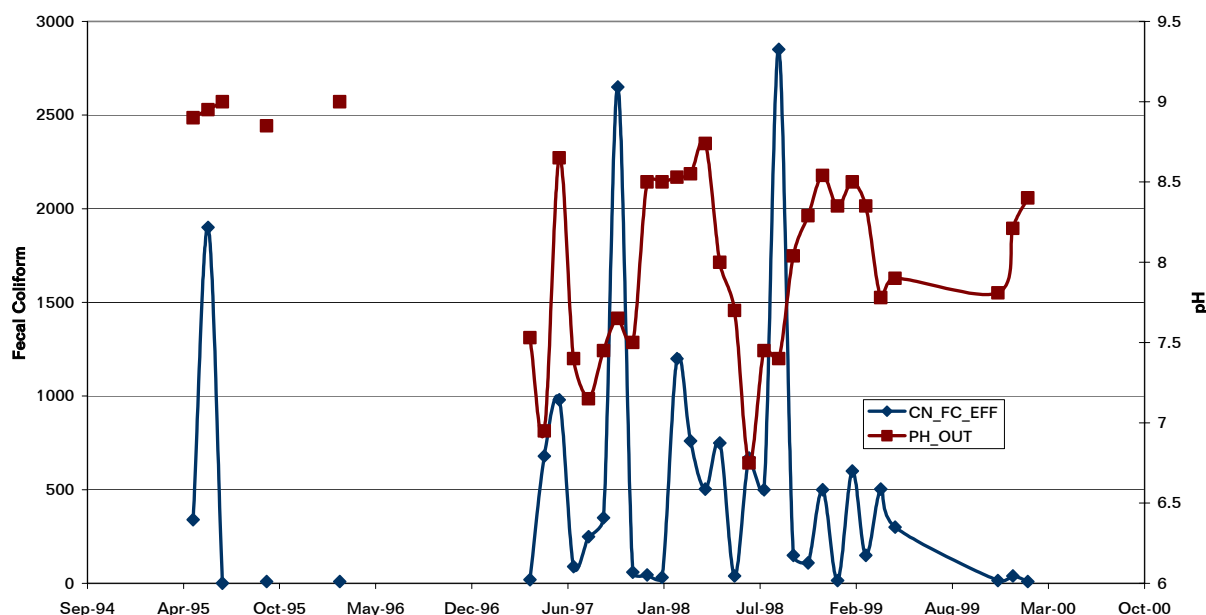
Avondale pH and FC

Data for these two categories have been plotted on the same graph. Data reflect the quality of the effluent, no influent measurements are taken for these parameters. The pH values plotted are an average of the minimum and maximum 30-day values that are reported in the monthly reports. Previous to the wetland implementation, data indicate that average pH values in the effluent were close to the maximum daily allowable of 9. Since the wetland implementation, pH values have consistently stayed within the allowable range of 6.5 to 9.

Fecal Coliform in the effluent is consistently well below the permit limitations of 6,000 organisms per 100ml.
